Enforcement Sensitive - Falcon Refinery Site Visit: January 14, 2015

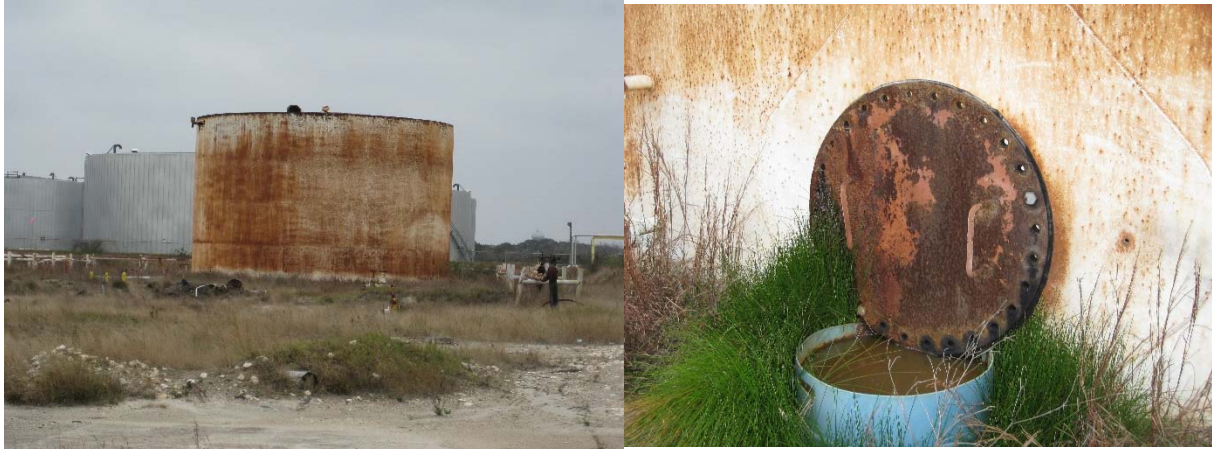
Tank 7: Notice only 2 manway bolts would indicate tank material removed and only water is still in tank about  $\frac{3}{4}$  way up the manway.

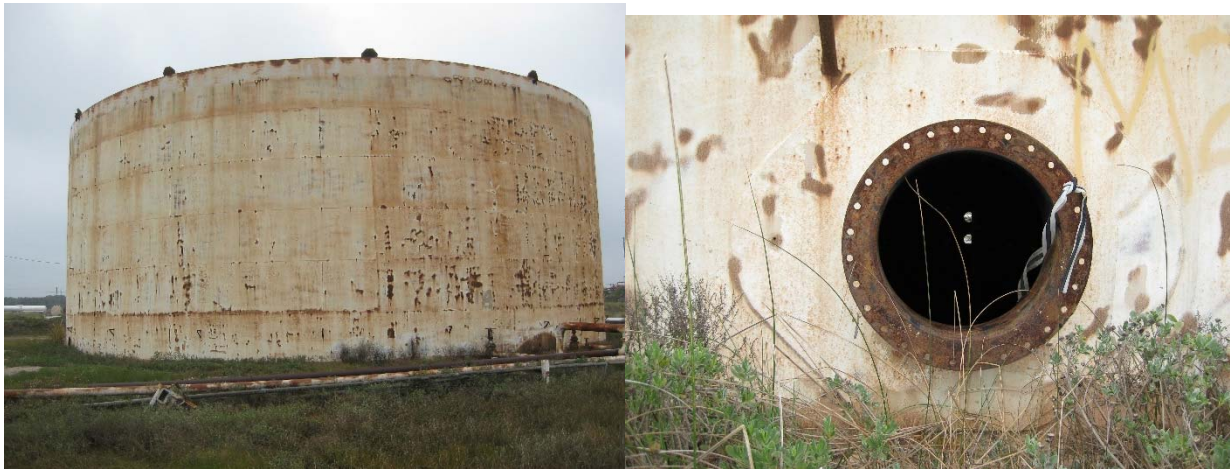
Tank 12: Tank with open manway. Appeared that it was about 6 – 12 inches of water.

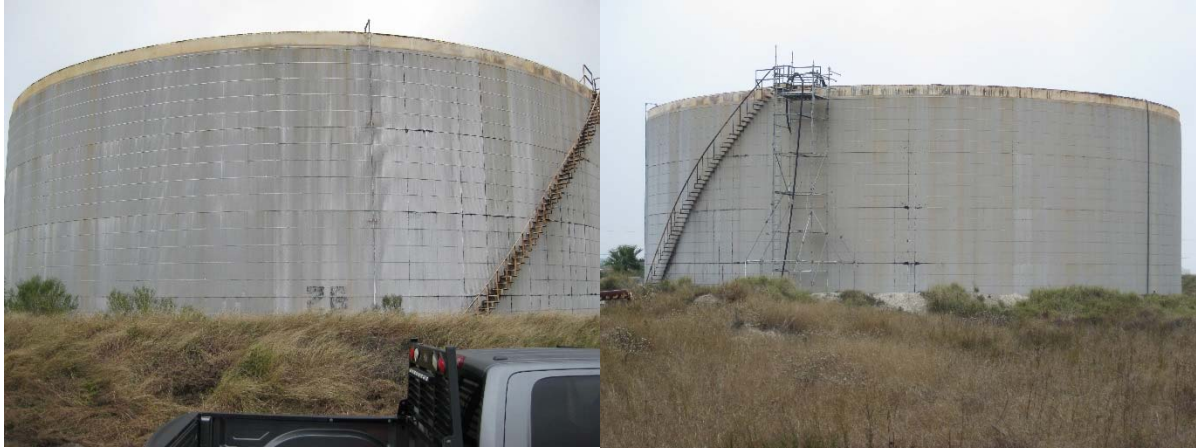
Tank 26: Insulated Tank – Volume of material in tank is unknown

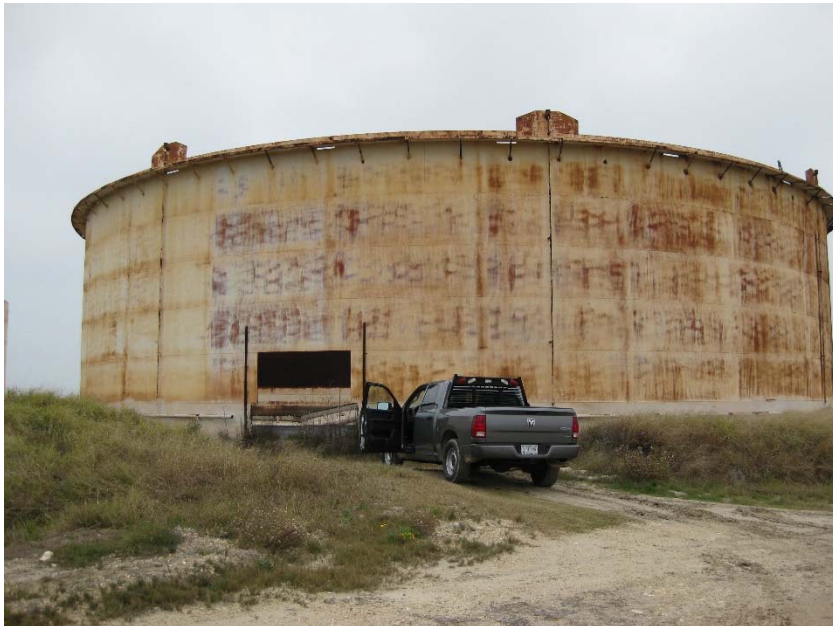
Tank 30: Big Hole in Tank with about 2 feet of Sludge and Water and portion of floating roof on the floor.

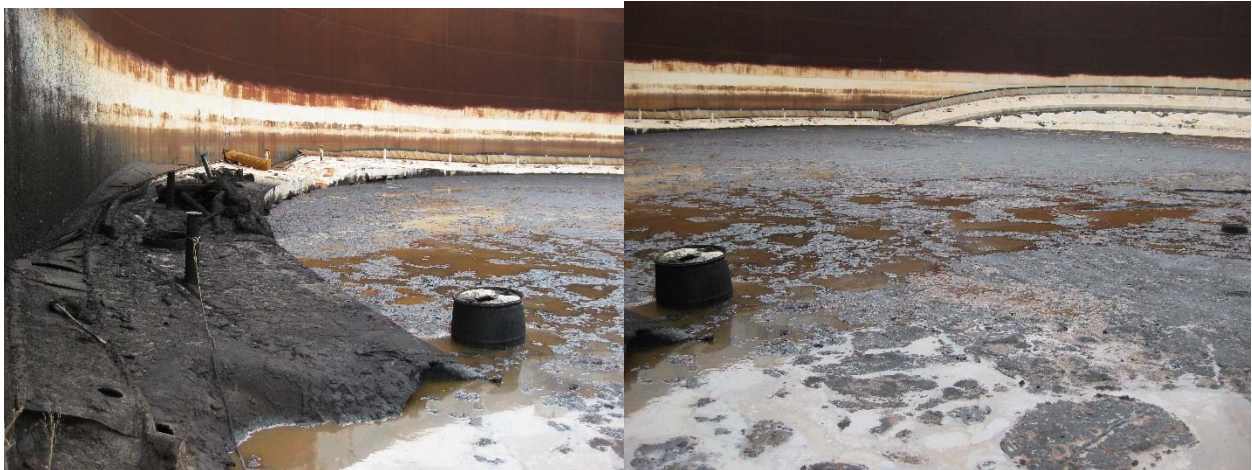
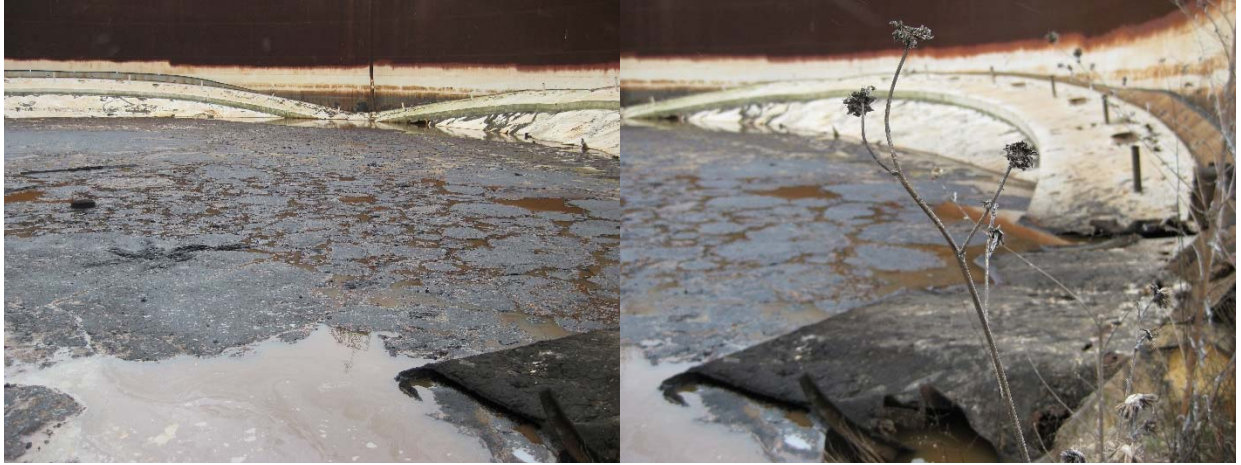
Tank 30: Interior view of Tank showing sludge and water and fallen portion of floating roof.

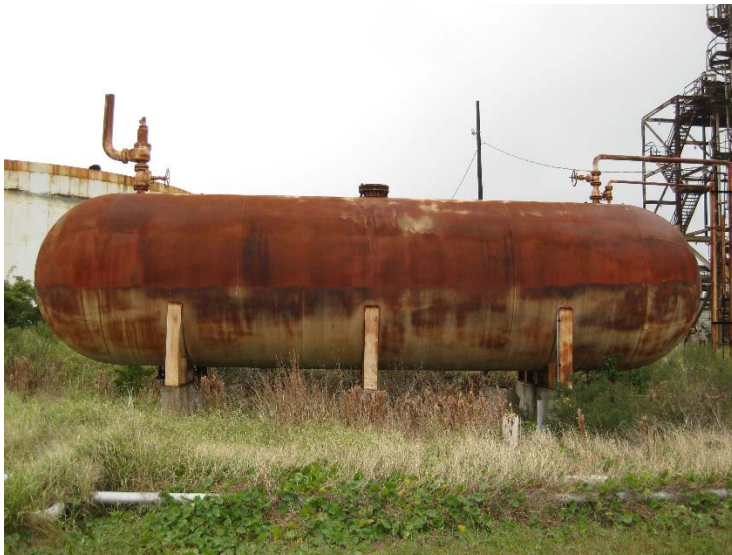
Butane Tank: Became a minor issue during Superior Crude spill when it was notice leaking. Supposedly has some thick hydrocarbon material in it.
